CANADIAN DAM ASSOCIATION

Vol. 24 No. 2

**A Study of the Use of GPS Sensors  
for Structural Monitoring of the  
Mactaquac Dam**

# A Study of the Use of GPS Sensors for Structural Monitoring of the Mactaquac Dam

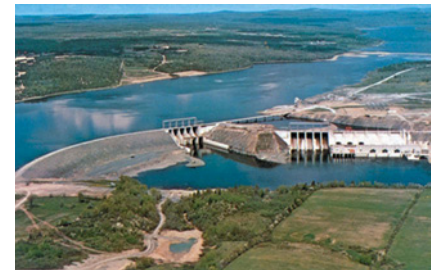
The NB Power Mactaquac Generating Station (Figure 1) is located 20 kilometers north of Fredericton, New Brunswick, on the Saint John River and was commissioned in 1968. Today the station has six units with a generating capacity of 672 megawatts.

Figure 1. Mactaquac Dam, Keswick Ridge, NB (from Agora, 2008)

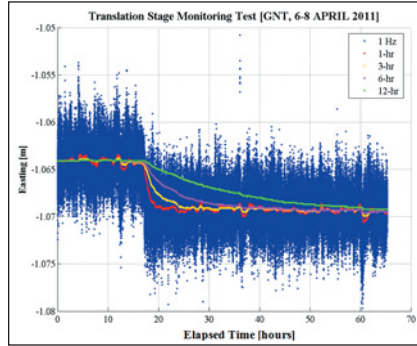
After approximately 15 hours of stationary data collection, the monitored station's antenna was moved 5 mm in the east direction using the translation stage. Figure 3 illustrates the east component solutions as output by the processing software. The observations were collected at 1 Hz. Varying degrees of a low-pass filter time constant (1, 3, 6 and 12 hours) are applied to

the 1 Hz solutions to illustrate the displacement trend. It can be seen that longer filtering time constants provide higher precision solutions but increase the time required for displacement detection. The 5 mm displacement is clearly illustrated by all filtered output types.

Figure 3: mmVu™ Software East Component Output

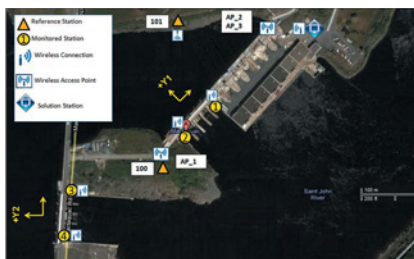
Each station uses Javad Delta G2T dual frequency GPS receivers with Javad TriAnt antennas. Data is streamed from each receiver to a Gemini NavSoft Technologies’ Solution Station running mmVu™ software. Moxa 2.4 Ghz WiFi infrastructure is implemented to facilitate data streaming. Three access points (AP 1, AP 2 and AP 3) are utilized to allow each receiver and the Solution Station to connect to the local network. The layout of the GPS network and communications infrastructure is illustrated in Figure 4.

Figure 4: GPS Network with Communications Infrastructure (background image from Google Maps)

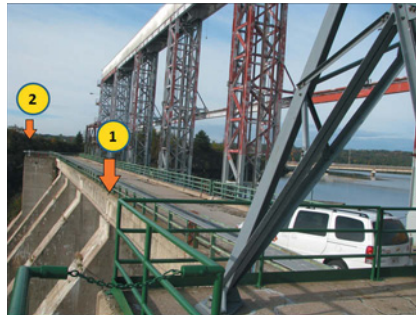
Station 1 is located within 2 metres of a transmission line tower (Figure 5). The tower is located

to the north of the antenna. The tower causes blockages in satellite signal and is a multipath and diffraction source. The location of the obstruction is important. The design of the GPS satellite constellation is such that there is a void of GPS satellites in the North sky. Thus, if an obstruction must be nearby a GPS antenna, it is the least offensive if it is located to the north. Unfortunately, the size of this obstruction is so large and it is so close to the antenna that it will also block satellite signals coming from the northeast and northwest quadrants. Also contributing to multipath, diffraction and limited satellite visibility at this site is the large intake gate located to the northwest of the antenna.

Figure 5: Station 1 (near arrow) with and Station 2 (far arrow) locations

Station 2 is located at the opposite end of the gate shown in Figure 5, so it experiences blockages in satellite signals from the northeast quadrant. It does not have to contend with a transmission tower as is the case at Station 1.

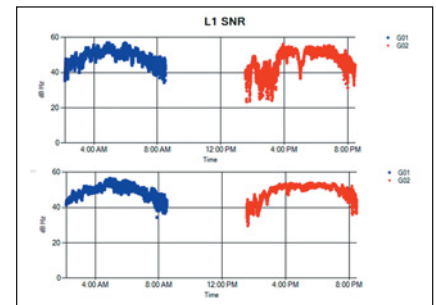
The transmission tower is a grid structure, so it allows GPS signals to pass through it. The effects of the obstruction on the satellite signal can be seen in Figure 6 which illustrates Signal-to-Noise Ratio (SNR) plots, (given by the dB-Hz unit) of satellite signals observed at Station 1

(top) and Station 4 (bottom). Station 100 is located in an area without obstructions. All satellite signals exhibit the signal signature shown where the SNR values gradually increase in value as the satellite rises and then decrease in value as the satellite sets. Station 1 tracks several satellites exhibiting the other signal signature shown, which is characteristic of a diffracted measurement. In this case, the previous parabolic signature is disrupted when obstructions increase the noise level in the observations. Noisier observations inevitably lead to noisier solutions unless they are properly handled.

Figure 6: Comparison of SNR values for Satellite 01 and Satellite 02 observed at Station 1 (top) and Station 4 (bottom)

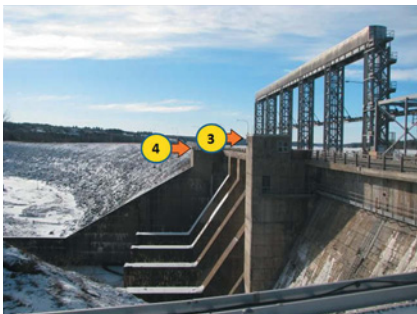
Stations 3 and 4 are also located within proximity to another gate located on the Diversion (Figure 8). These stations are located further away from the gate than Stations 1 and 2, which slightly reduces its impact in reducing satellite visibility. The gate is located to the southwest of Station 3 and northwest of Station 4.

Figure 8: Station 3 (near arrow) and Station 4 (far arrow)

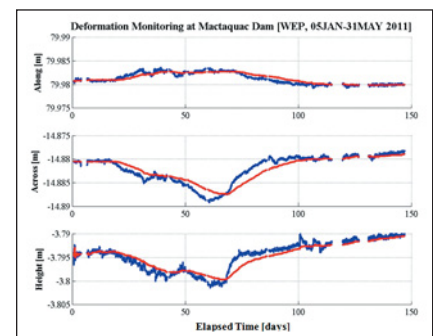
- b. Both Station 1 and Station 2 show gradual changes in the across direction of about 8 mm which peak near the beginning of March and come back to their original positions towards the end of the month.
- c. Both Station 1 and Station 2 show gradual changes in height of about 8 mm which peak near the beginning of March and come back to their original positions towards the end of the month.

Figure 10: Station 100 to Station 2 (WEP) Baseline Solution Components

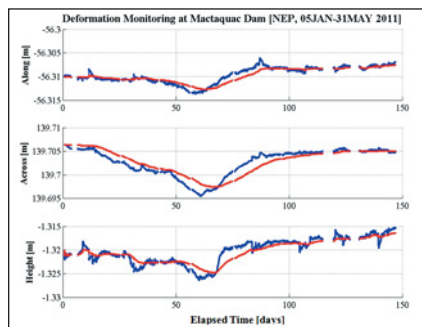
Figure 11 and Figure 12 illustrate the along track (along the crest of the Diversion), across track (across the crest Diversion) and height component positions of the GPS antennas from 05 Jan 2011 to 31 May 2011 at Stations 3 (NEP) and 4 (SEP) respectively. The following comments can be made:

- b. Station 3 and Station 4 undergo different displacement trends in the along track direction.
- c. Both Station 3 and Station 4 show gradual changes in the across direction of about 8 mm which peak near the beginning of March and come back to their original positions towards the end of the month.
- d. Both Station 1 and Station 2 show gradual changes in height of about 8 mm which peak near the beginning of March and come back to their original positions towards the end of the month.

Figure 11: Station 100 to Station 3 (NEP) Baseline Solution Components

Looking at the monitored stations collectively, it can be seen that all monitored stations experience the same gradual changes in both the across and height directions which peak near the beginning of March and come back to their original positions towards the end of the month.

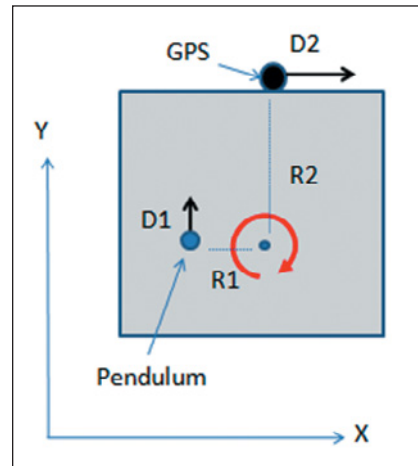
The deformation behaviour of the structure and the locations of the instrumentation sampling the deformation behaviour can lead to seemingly incompatible results. To illustrate the point, Figure 15 presents the scenario in which a structure is rotating. An inverted pendulum and GPS setup are used to sample the deformation behaviour. Because of the different locations of the instrumentation on the structure, two entirely different pictures are presented by the technologies. For the inverted pendulum which is located at radial distance R1 from the rotation point,

a displacement of D1 in the +Y direction is shown. For the GPS antenna which is located at radial distance R2 from the rotation point, a displacement of D3 in the +X direction is shown. The magnitudes of the displacements are directly proportional to the distance from the rotation point.

Figure 15: Sampling of the Same Deformation Behaviour with Different Displacement Results

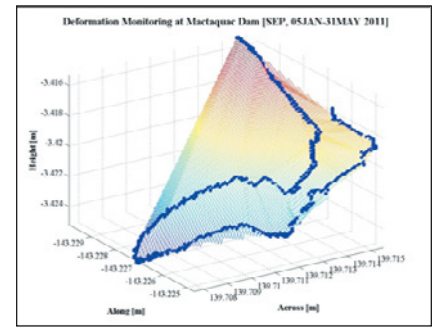
Figure 16 illustrates the 3D path of Station 4 over this data collection period. It shows that the deformation behaviour is complex and that a scenario such as that seen in Figure 15 is not out of the question. As annual data becomes available, it will be possible to determine if the behaviour repeats.

Figure 16: 3D path of Station 4 GPS Antenna
